**SOUTHWESTERN COASTAL BASIN  
NEW CANAAN, CONNECTICUT**

**.NEW CANAAN RESERVOIR DAM  
CT 00055**

**PHASE 1 INSPECTION REPORT  
NATIONAL DAM INSPECTION PROGRAM**

**FEBRUARY, 1980**

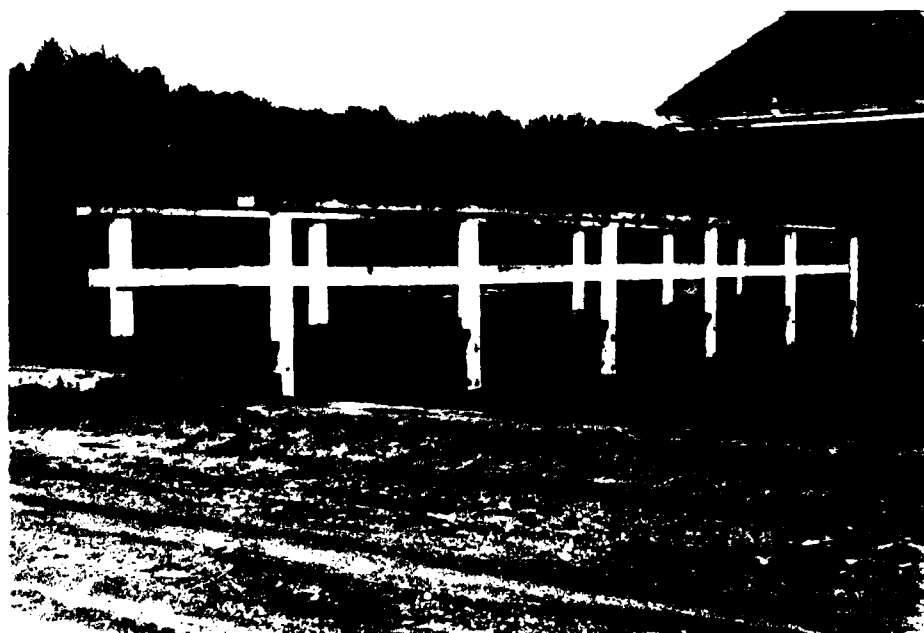
4. **Gate House:** The gate house is a concrete and brick structure located in the reservoir 38 feet upstream of the dam and is generally in good condition (Photo C-2). Access to the house is via a steel service bridge with a timber deck (Photo C-8). The steel portion appears sound; however, the deck is deteriorating and the wood railing is in poor condition.

C-8 GATE HOUSE AND SERVICE BRIDGE

The timber decks and the railing of the service bridges and the spalling concrete surfaces of the wall along the upstream face of the dam, the spillway wingwalls and training walls should be rehabilitated.

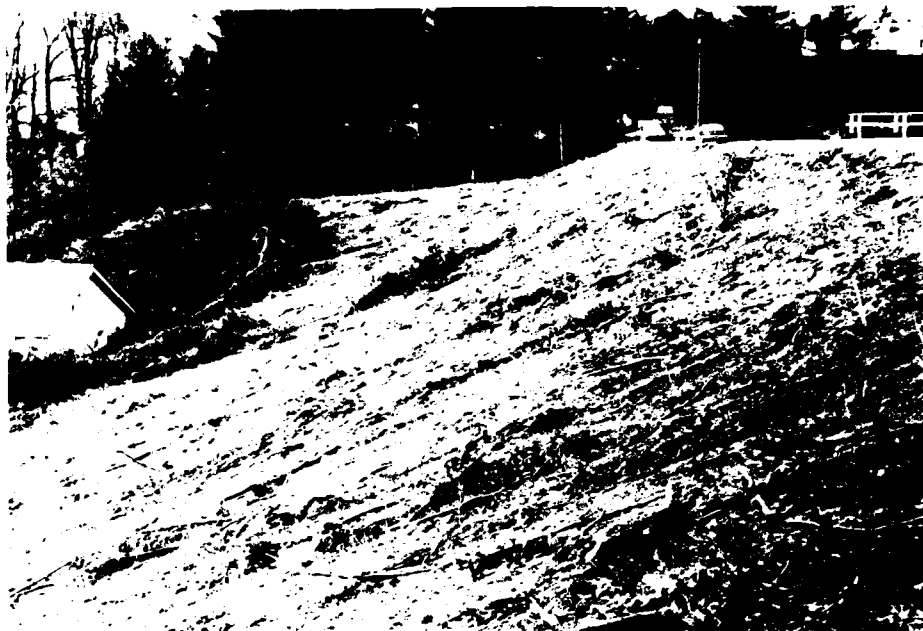
3. **Downstream Slope:** The downstream face is an earth embankment with a slope of approximately 3H:1V (Photos C-13, C-14). There is a rock outcrop in the center of the embankment at the toe. Evergreen trees which were planted on the embankment in the early 1940's had recently been cut; however, the stumps remain. Because of the recent removal of the trees, the slope is essentially unvegetated, resulting in the formation of minor gullies from storm runoff. A few trees remain along the edges of the dam primarily along the spillway discharge channel. Seepage was noted from one location at each edge of the embankment, both with steady clear flows of 5 to 10 GPM (Photo C-16). These have reportedly been in existence since at least 1932. Other wet spots on the embankment were noted, although they may have been due to a recent rainfall (Photo C-15).

C-13 DOWNSTREAM FACE OF DAM - LOOKING WEST

1. Ground cover vegetation should be established on the downstream face as soon as possible.
2. The remaining trees on the edges of the embankment should be removed.
3. The seepage on the downstream slope should be monitored to note any change from the existing conditions.
4. The concrete wall on the upstream face of the dam, the spillway wing-walls, training walls, and discharge channel floor should be rehabilitated to their original condition.
5. The deck of the service bridge to the gate house should be rehabilitated.
6. Institute a program of annual periodic technical inspection.
7. Develop a formal flood warning and surveillance plan, including round-the-clock monitoring during heavy precipitation.
